# CONSIDERATION OF TOURISM DEVELOPMENT AND ENVIRONMENTAL DEGRADATION IN THE SANICA RIVER VALLEY (NORTHWEST BOSNIA AND HERZEGOVINA)

This paper focuses on the Sanica River, located in the municipalities of Ključ and Sanski Most, whose course has been exposed to strong anthropogenic pressure in recent years. In certain sections, large retaining walls and embankments have been constructed, weekend houses built, artificial dams erected, trees removed, and illegal waste disposal sites formed. The aim of this paper is to highlight the consequences of uncoordinated spatial management and inconsistent environmental policies, as well as their implications for tourism development and the degradation of major tourist attractions. The purpose is to encourage all relevant stakeholders and institutions to take greater responsibility for environmental protection and to promote a more balanced and sustainable development of tourism. The research methodology includes remote sensing and repeat photography, among other methods. The first part of the paper provides an overview of previous research and outlines the specific characteristics of the Sanica River, while the second part focuses on tourism d

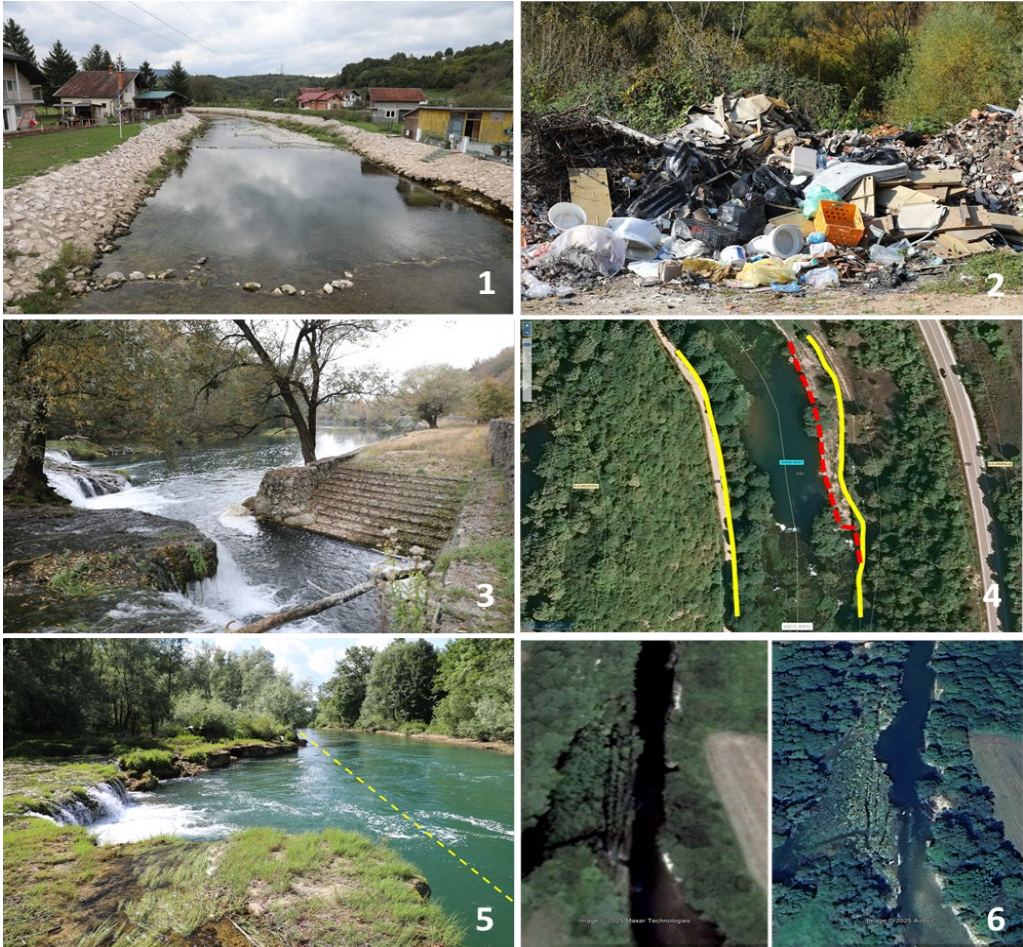
**Fig. 1.** (top left): Riverbank embankments on the Sanica River near the settlement of Donji Budelj;

**Fig. 2.** (top right): Municipal and construction waste dump at the Kordići site, located directly along the Sanica River;

**Fig. 3.** (center left): Stone wall and damaged part of the waterfall on the Sanica River near the settlement of Vrhpolje;

**Fig. 4.** (center right): Position of the riverbank (yellow line) and the stone wall in the Sanica riverbed (red line), according to cadastral data from the Federal Geodetic Administration;

**Fig. 5.** (bottom left): Waterfall at the mouth of the Sanica into the Sana with approximate position (yellow line) before collapse. Photographed in summer 2025;

**Fig. 6.** (bottom right): Changes in the morphology of the waterfall from 2011 (before the downstream Sana riverbed regulation) to 2025, based on Google Earth satellite images.

Research indicates that at 25 locations between 2010 and 2025, significant changes were recorded in the riverbed and along the banks, including concrete embankments, deepening and narrowing of the riverbed, construction of small dams, disposal of municipal waste near the banks, and increased erosion due to tree cutting. Larger works, including riverbed regulation and the construction of embankments, are particularly visible along the stretch from the settlement of Vrelo to Donji Budelj (Fig. 1.). The impact of individual activities, although limited to smaller areas, significantly degrades the riverbed and surrounding environment due to the number of affected locations. One example of individual impact on riverbed degradation is the construction of stone walls and the destruction of the waterfall along the right bank of the Sanica River, between Vrhpolje and Hrustovo (Fig. 3. and 4.). Similarly, the middle course of the river is affected by large deposits of municipal and construction waste, particularly at the Kordići site (Fig. 2.).
